Manhole Inspection Summary

Manhole # S05EE2018MH

Insp Date: **7/17/06 10:23 AM**

Location Address: **2703 TANEY RD**

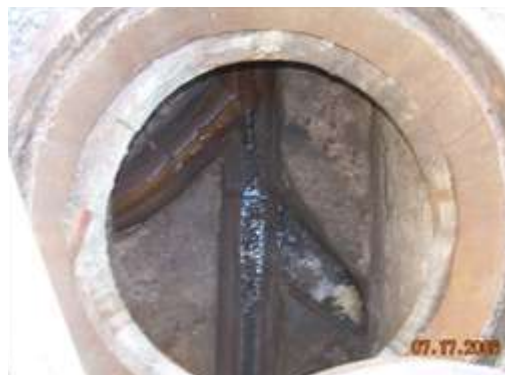
Top View

Frame leaks. Adjustment and Corbel infiltration. Bench debris. Channel debris.

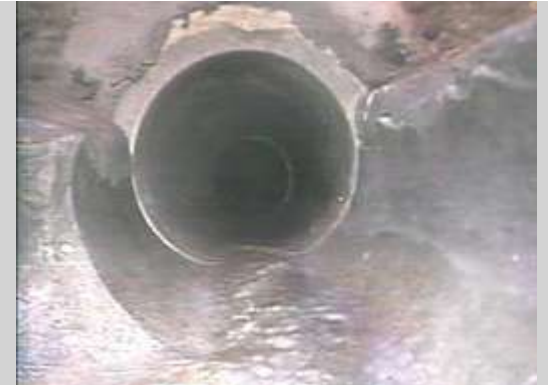
8 in. Circular Gravity Sewer Pipe Out @ 12 O'Clock

Infiltration: **Evidence** Pipe Seal Cond: **Unknown**

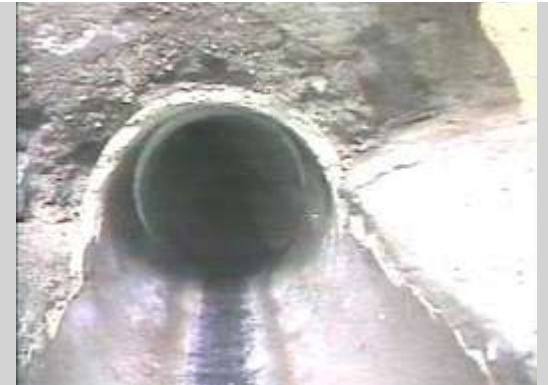
8 in. Circular Gravity Sewer

Barrel deterioration and infiltration.
